ASBESTOS RE-INSPECTION SURVEY

One Fifty
148-150 Victoria Road,
Swindon,
SN1 3BU

Client:	Graham + Sibbald incorporating Keningtons
Report Reference:	190122
Date:	January 2023
Lead Surveyor:	Andrew Alderson BSc (HONS)

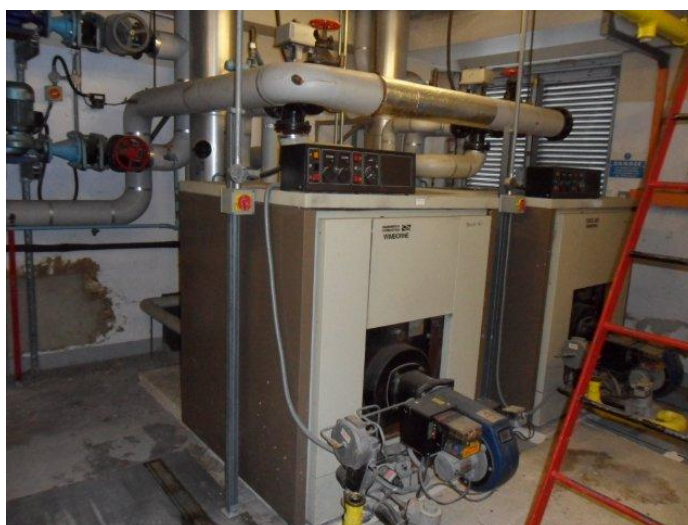
Project Number	190122		Building	Main Building - Communal Areas	
Inspection Reference	IR001		Floor	Third Floor	
Inspection Date	18th January 2023		Area	A001-Lower Plant Room	
Survey Type	Re-inspection Survey		Sample Number	Strongly Presumed	
Asbestos	Yes	Extent	Small amounts	Certificate Number	N/A
Description	Gaskets to pipework (Ref 1055882-023)- presumed to any remaining pipework

Product type	Gasket	2
Damage extent	Good condition	0
Surface treatment	Reinforced composite material	0
Asbestos type	Chrysotile	1
Material assessment total		3

Risk Rating	Very Low	Total Assessment Score:	-
--------------------	-----------------	--------------------------------	---

Recommendations	Manage in accordance with your asbestos management plan and re-inspect on an annual basis or when circumstances change.
Complete By:	January 2024

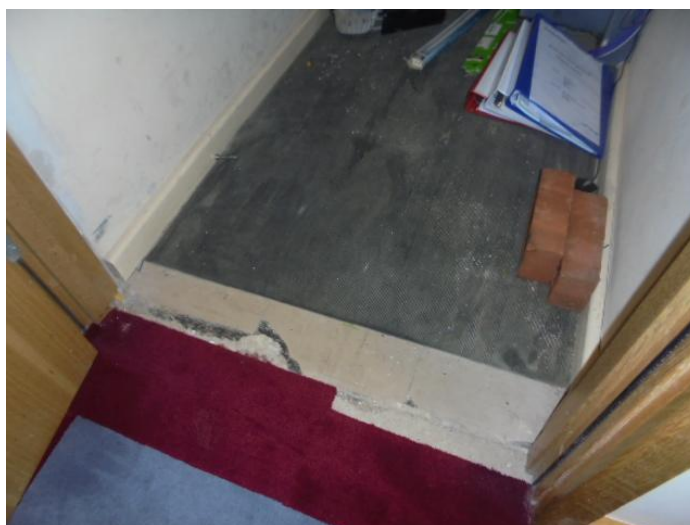
Project Number	190122	Building	Main Building - Communal Areas
Inspection Reference	IR002	Floor	Third Floor
Inspection Date	18th January 2023	Area	A002-Electrical Intake Room
Survey Type	Re-inspection Survey	Sample Number	Strongly Presumed
Asbestos	Yes	Extent	4m ²
		Certificate Number	N/A
Description	Beige thermoplastic floor tile & bitumen adhesive (Ref 1055882-037)

Product type	Floor tiles	1
Damage extent	Low damage	1
Surface treatment	Reinforced composite material	0
Asbestos type	Chrysotile (in tile and bitumen)	1
Material assessment total		3

Risk Rating	Very Low	Total Assessment Score:	-
--------------------	----------	--------------------------------	---

Recommendations	Manage in accordance with your asbestos management plan and re-inspect on an annual basis or when circumstances change.
Complete By:	January 2024

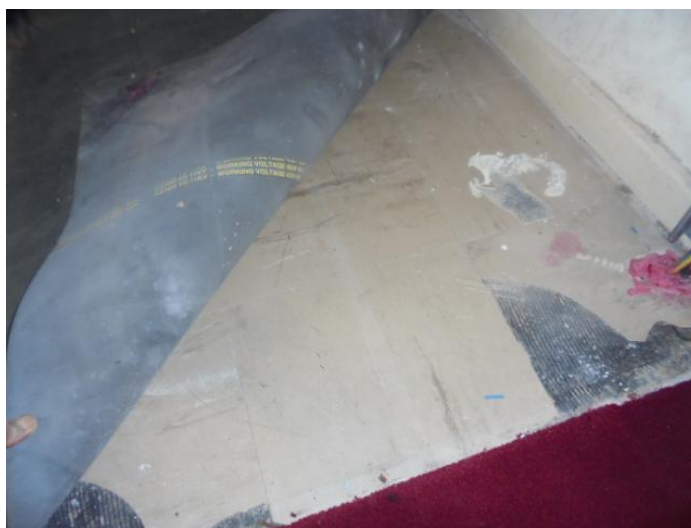
Project Number	190122	Building	Main Building - Communal Areas
Inspection Reference	IR003	Floor	Second Floor
Inspection Date	18th January 2023	Area	A003-Electrical Intake Room
Survey Type	Re-inspection Survey	Sample Number	Strongly Presumed
Asbestos	Yes	Extent	4m ²
		Certificate Number	N/A
Description	Beige thermoplastic floor tile & bitumen adhesive (Ref 1055882-033)

Product type	Floor tiles	1
Damage extent	Low damage	1
Surface treatment	Reinforced composite material	0
Asbestos type	Chrysotile (in tile and bitumen)	1
Material assessment total		3

Risk Rating	Very Low	Total Assessment Score:	-
--------------------	-----------------	--------------------------------	---

Recommendations	Manage in accordance with your asbestos management plan and re-inspect on an annual basis or when circumstances change.
Complete By:	January 2024

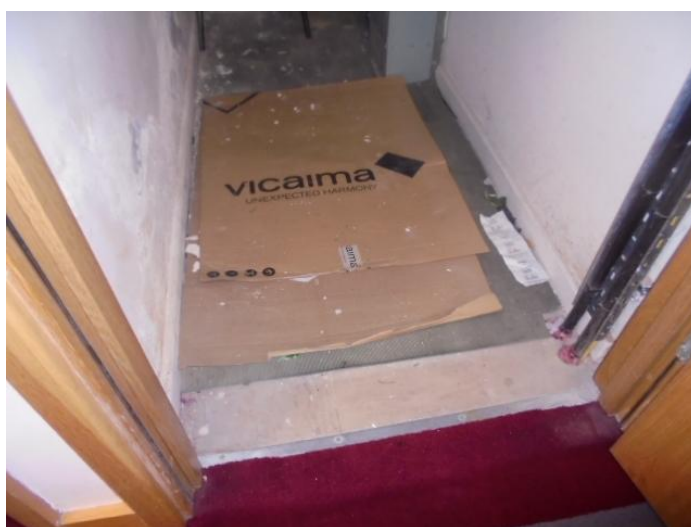
Project Number	190122	Building	Main Building - Communal Areas
Inspection Reference	IR004	Floor	First Floor
Inspection Date	18th January 2023	Area	A004-Electrical Intake Room
Survey Type	Re-inspection Survey	Sample Number	Strongly Presumed
Asbestos	Yes	Extent	4m ²
		Certificate Number	N/A
Description	Beige thermoplastic floor tile & bitumen adhesive (Ref 1055882-029) - no key available

Product type	Floor tiles	1
Damage extent	Low damage	1
Surface treatment	Reinforced composite material	0
Asbestos type	Chrysotile (in tile and bitumen)	1
Material assessment total		3

Risk Rating	Very Low	Total Assessment Score:	-
--------------------	-----------------	--------------------------------	---

Recommendations	Manage in accordance with your asbestos management plan and re-inspect on an annual basis or when circumstances change.
Complete By:	January 2024

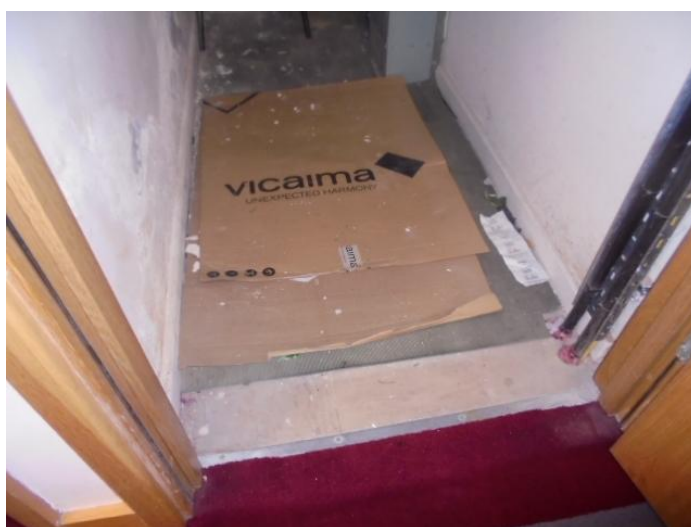
Project Number	190122	Building	Main Building - Communal Areas
Inspection Reference	IR005	Floor	Ground Floor
Inspection Date	18th January 2023	Area	A005-Electrical Intake Room
Survey Type	Re-inspection Survey	Sample Number	Strongly Presumed
Asbestos	Yes	Extent	6m ²
		Certificate Number	N/A
Description	Beige thermoplastic floor tile & bitumen adhesive (Ref 1055882-028)

Product type	Floor tiles	1
Damage extent	Low damage	1
Surface treatment	Reinforced composite material	0
Asbestos type	Chrysotile (in tile and bitumen)	1
Material assessment total		3

Risk Rating	Very Low	Total Assessment Score:	-
--------------------	-----------------	--------------------------------	---

Recommendations	Manage in accordance with your asbestos management plan and re-inspect on an annual basis or when circumstances change.
Complete By:	January 2024

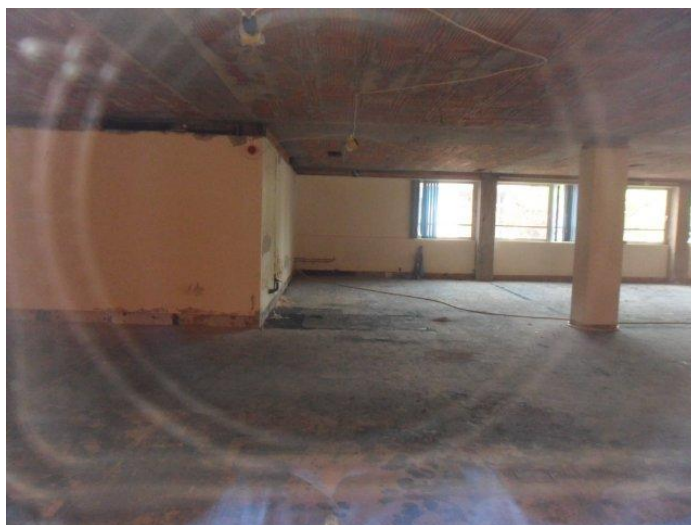
Project Number	190122		Building	Main Building - Communal Areas	
Inspection Reference	IR006		Floor	Ground Floor	
Inspection Date	3rd August 2011		Area	A006-Kitchen	
Survey Type	Re-inspection Survey		Sample Number	Strongly Presumed	
Asbestos	No	Extent	0m ²	Certificate Number	N/A
Description	Kitchen floor tiles presumed removed as part of refurbishment

Risk Rating	Removed	Total Assessment Score:	-
--------------------	---------	--------------------------------	---

Recommendations	No further action required.
Complete By:	Not applicable
